## CASE STUDY

### THREE BARRIERS WELL INTEGRITY EVALUATION

#### MULTI BARRIER THICKNESS TOOL (MBTT)

**Location:** Middle East, Oman.

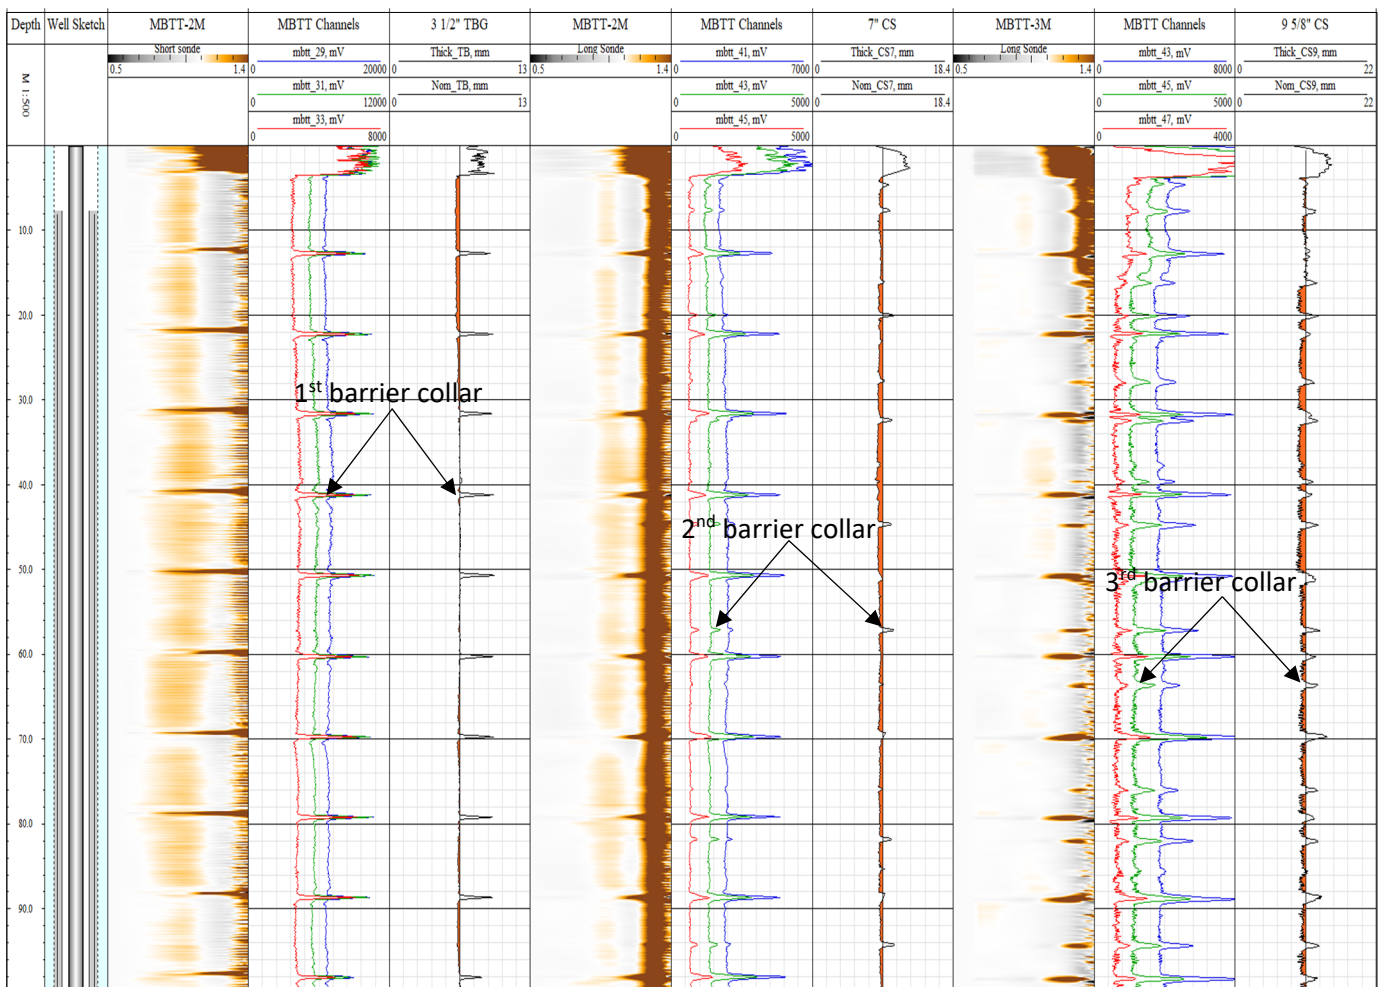
- Overall, the 3 1/2" tubing pipes are in good condition. However, 3 1/2" joint number 18 is characterized by 10% localized metal loss from nominal.
- Overall, the 7" casing pipes are in good condition. Perforations are of good quality.
- Overall, 9 5/8" casing pipes are in good condition.

- The 9 5/8" casing shoe was detected at 296.0 m.
- The 7" perforated interval was found at 1090.6-1093.6 m.
- The 3 1/2" tubing PKR revealed at 1034.7-1037.4 m.
- The 3 1/2" tubing end was detected at 1051.5 m.
