CASE STUDY

FLOWJET TECHNOLOGY, **STREAM™** AND MBTT CORROSION LOGGING ALLOW TO EVALUATE PERFORATIONS PERFORMANCE AND WELL OPTIMIZATION FOR HIGH WATER CUT VERTICAL OIL PRODUCER

Location: North Africa

Well type: vertical oil producer

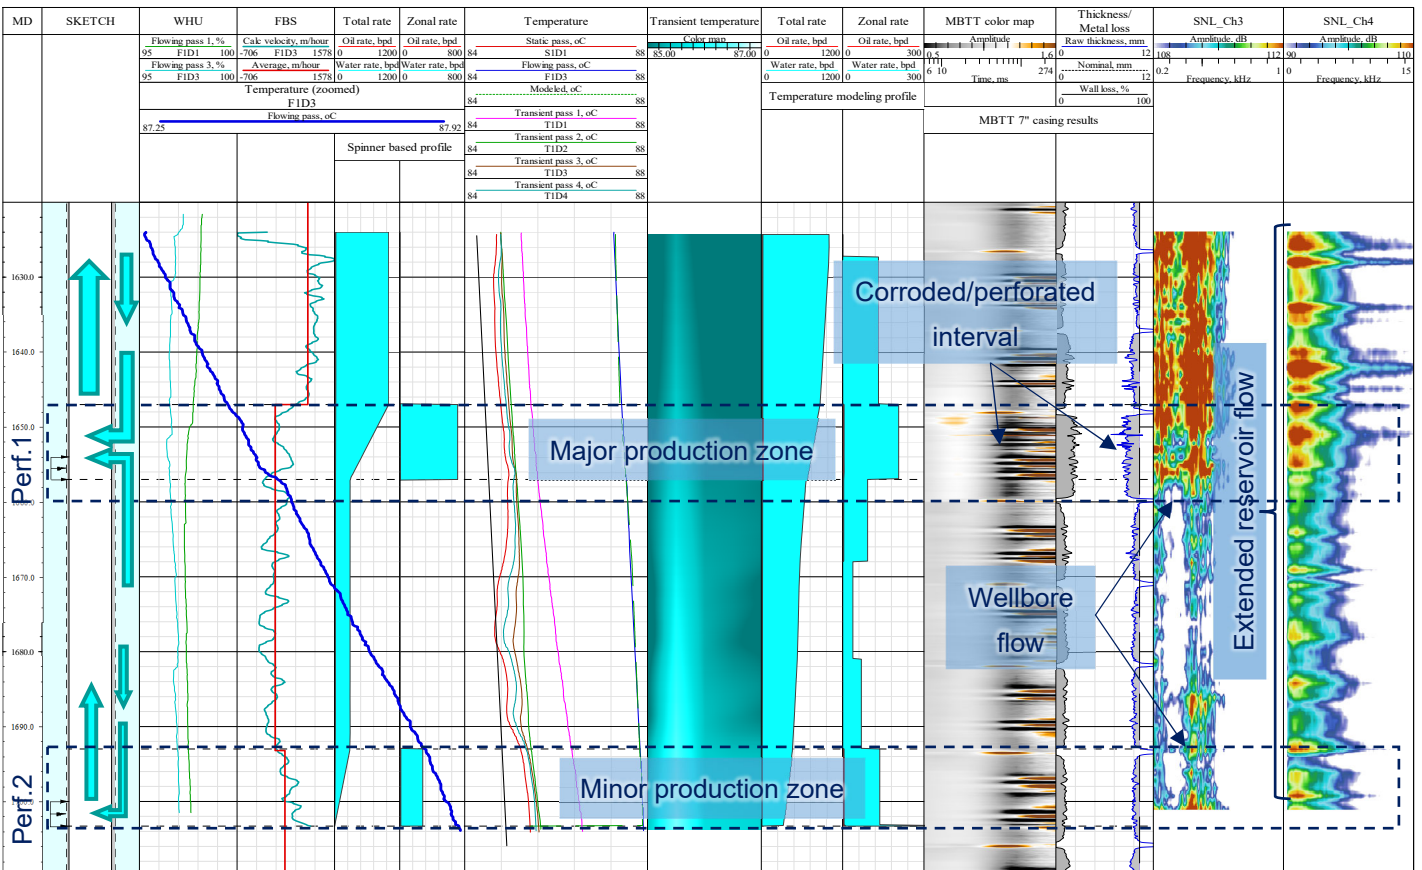
Based on the FBS results the main production zone relates to the top perforation (Perf. 1 on the chart below) and the overlying corrosion interval. Both zones were clearly detected by the MBTT as a significant metal loss. The conclusion is correlated with gradient changes on a zoomed temperature curve (bold blue on the chart below) and low-frequency noise anomaly on FIND data confirming the upward wellbore flow. The T-FLOW profile matches the spinner-based profile regarding the main production zone. However, the profile also shows an extended reservoir contribution zone above the main production zone. The same is confirmed by contrast extended noise anomaly on a high-frequency domain of FIND data.

Another production zone was classified as a minor and corresponds to the bottom perforation (Perf. 2 on the chart below). Such a conclusion is supported by the spinner-based and T-FLOW profiles, as well as FIND response with continuously increasing low-frequency signal towards the bottom of the logging interval confirming the upward wellbore flow.

- determination of a main production zone (perforations performance evaluation)
- continuous communication of formation fluid (predominantly water) across the entire reservoir section behind the casing
- casing integrity issue above the Perf. 1 that opened for the flow
