CASE STUDY

CASING LEAK DETECTION IN ESP OIL PRODUCER BY FIND (SNL) & MBTT CORROSION LOGGING

Location: Middle East

Well type: ESP oil producer

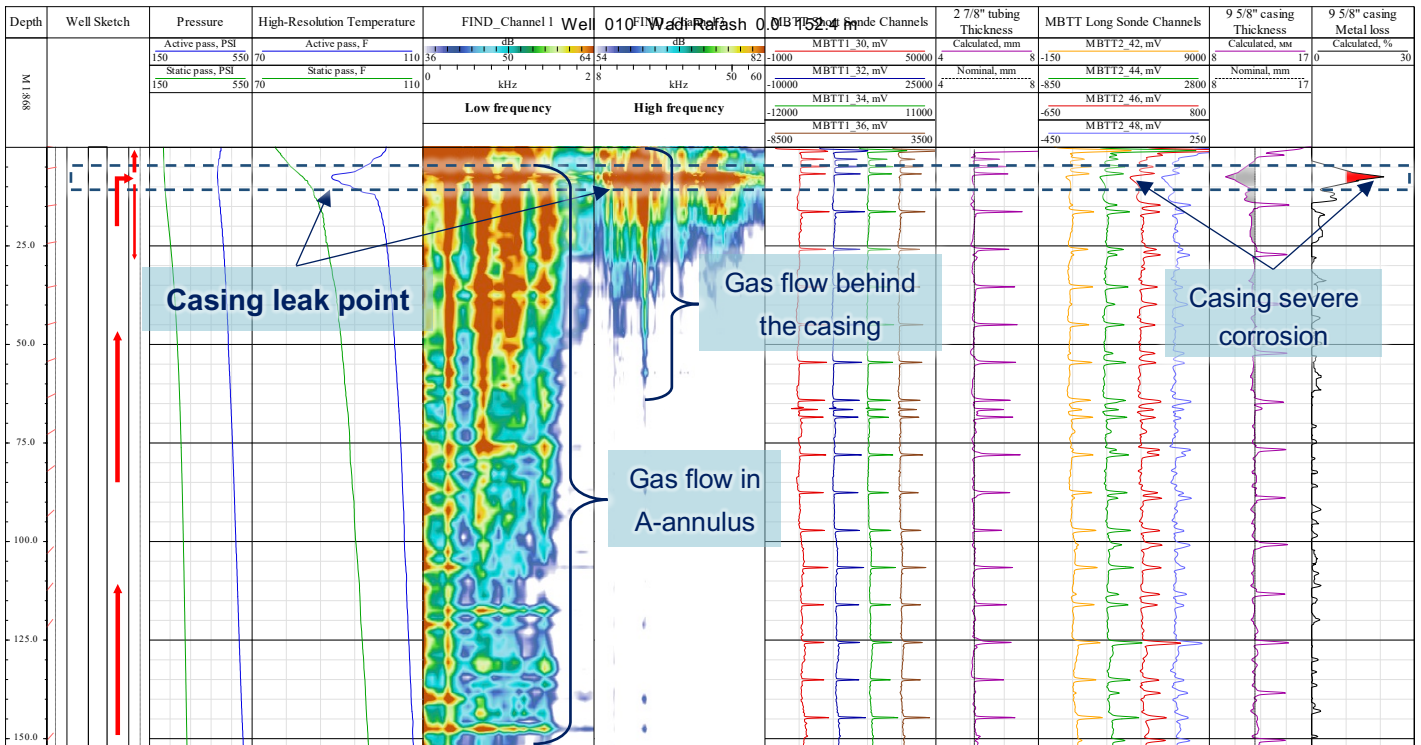
FIND Channel 3 from active pass recorded a narrow horizontal noise anomaly of a wide frequency range located close to the surface which is related to the casing leak point. It was confirmed by a negative spiky anomaly on the active pass HRT curve. In addition, the MBTT data analysis revealed a zone of severe 9 5/8" casing corrosion across the leak point area. There is an explicit vertically oriented noise anomaly in the low/mid-frequency noise domain recorded by FIND Channel 1 indicating the A-annulus upward gas flow. FIND Channel 3 in high-frequency noise domain presented vertically oriented noise anomaly confirming the gas flow behind the casing across the leak point up to the surface.

- Casing leak point
- Corrosion zone around casing leak point
- Interval of A-annulus gas flow
- Interval of behind-the-casing gas flow
