LEAK DETECTION IN VERTICAL WATER INJECTOR BY FIND & HIGH-RESOLUTION TEMPERATURE TOOL

Location: West Africa

Well type: offshore vertical water injector

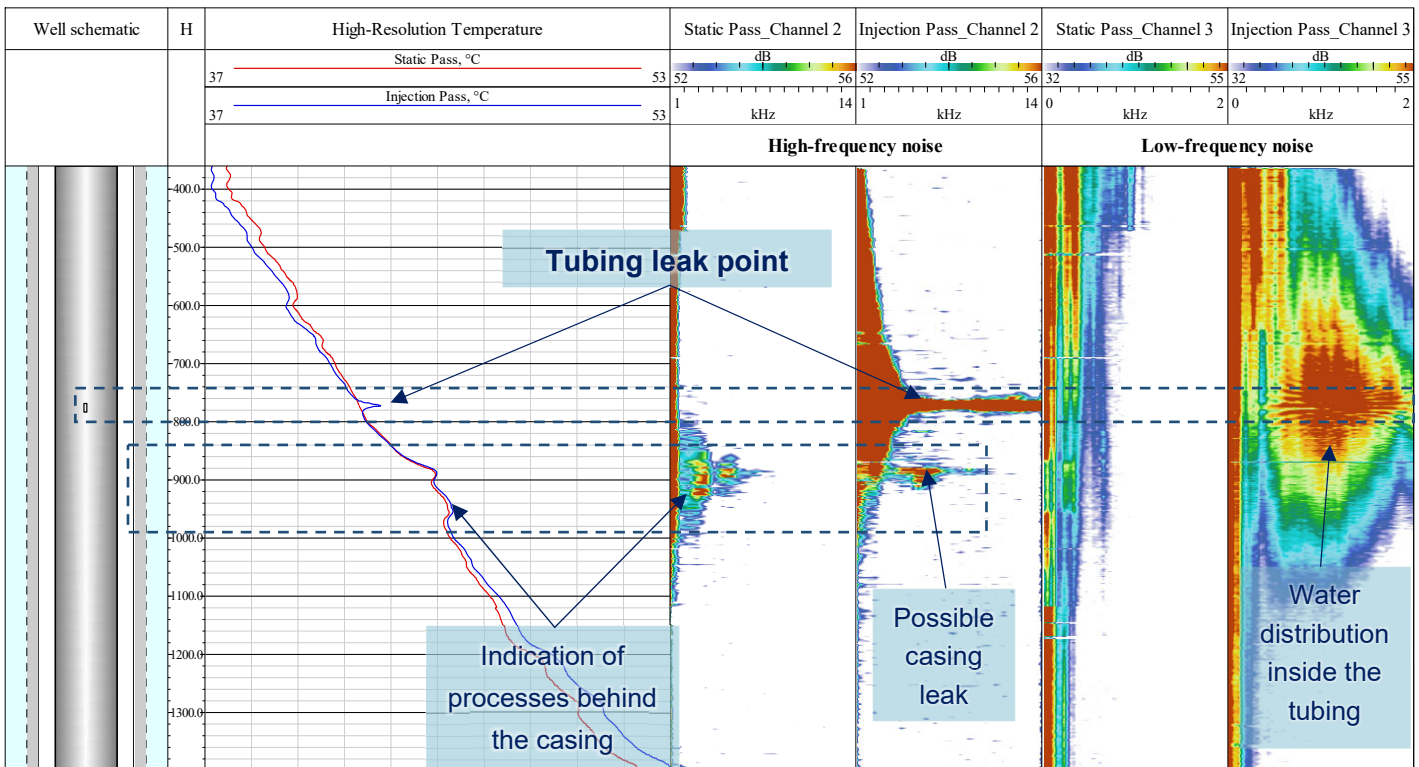
The SNL injection pass data revealed the tubing leak point (refer to the chart below) by high amplitude noise anomalies on a high-frequency domain (Channel 2) and low-frequency domain (Channel 3). The conclusion is also confirmed by a well-marked spiky anomaly on the HPT curve of the injection pass. There is an additional wave-shaped temperature anomaly observed on the HPT curve during both static and injection passes below the tubing leak point. The SNL readings showed explicit noise response on the high-frequency domain (Channel 2) across the same interval. The amplitude of the noise anomaly during the injection pass was higher, and the magnitude was more localized. Therefore, mentioned HPT and SNL anomalies were interpreted as an indication of channeling behind the casing with possible casing leak.

- tubing leak point was localized
- interval of flow behind the casing and possible casing leak were detected
- integrity evaluation of several barriers within one log
