## CASE STUDY

### LEAK DETECTION BY FIND (SNL) & MBTT3 CORROSION LOGGING ALLOWED THE LOCALIZATION THE 3<sup>RD</sup> PIPE LEAK POINT AND B-ANNULUS FLOW

**Location:** West Africa

**Well type:** ESP oil producer

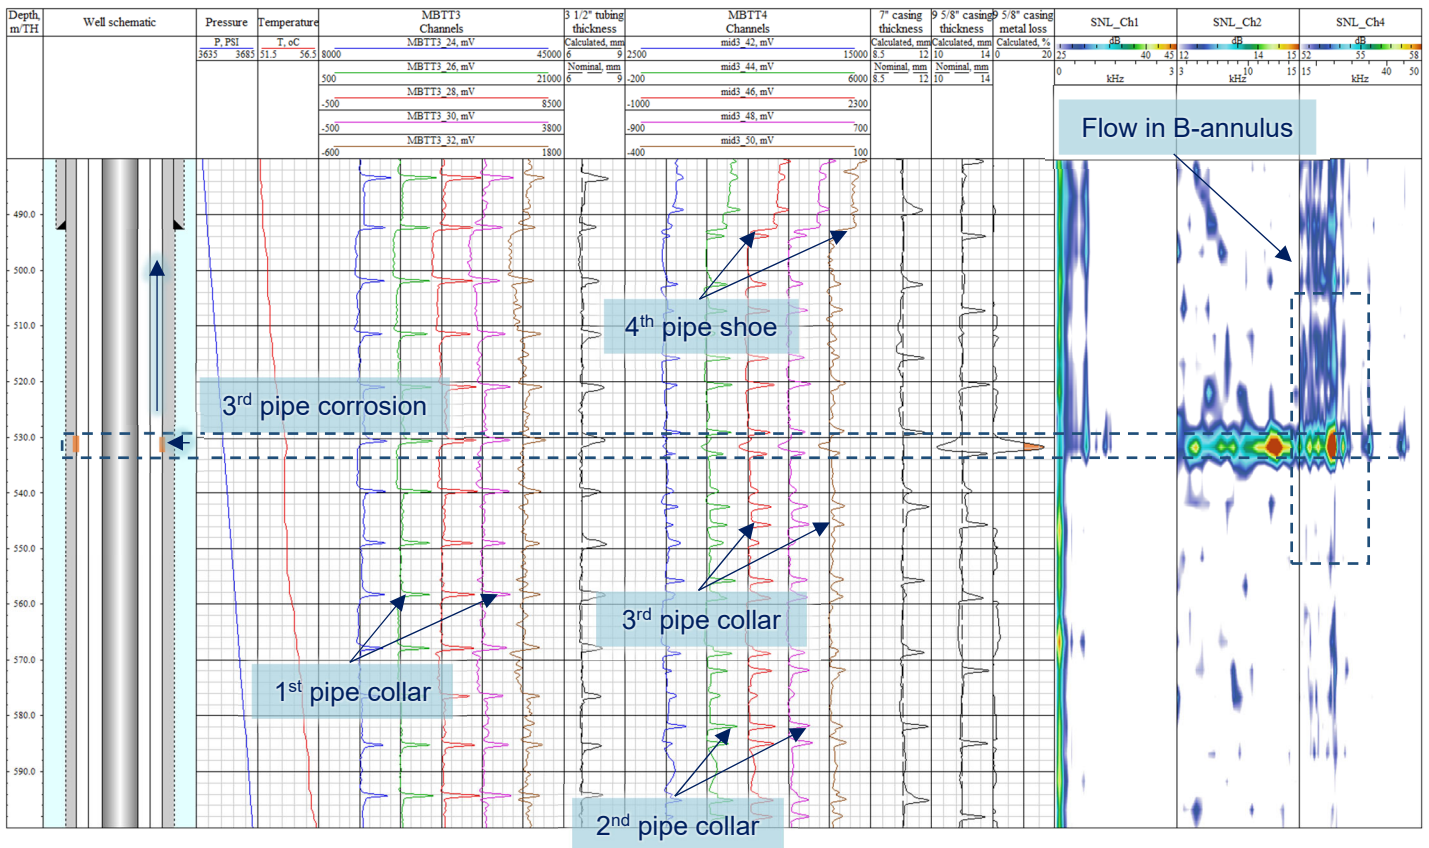
FIND Channels 2 and 4 revealed narrow horizontal noise anomalies of a wide frequency range (3.0-45.0 kHz) related to a minor leak point in the casing as well as an indication of the flow behind the casing. The MBTT4 tool confirmed the leak by a localized interval of moderate corrosion on the 3rd pipe (9 5/8" casing) with 17% of the average circumferential metal loss. There is a good indication of the 13 3/8" casing shoe which is the 4th pipe.
