### CORROSION LOGGING BY **MBTT3** IN ABANDONED GL OIL PRODUCER WELL ALLOWED TO PREVENT THE RISK OF PARTED TUBING DURING PLANNED WO

**Location:** Middle East

**Well type:** horizontal water injector.

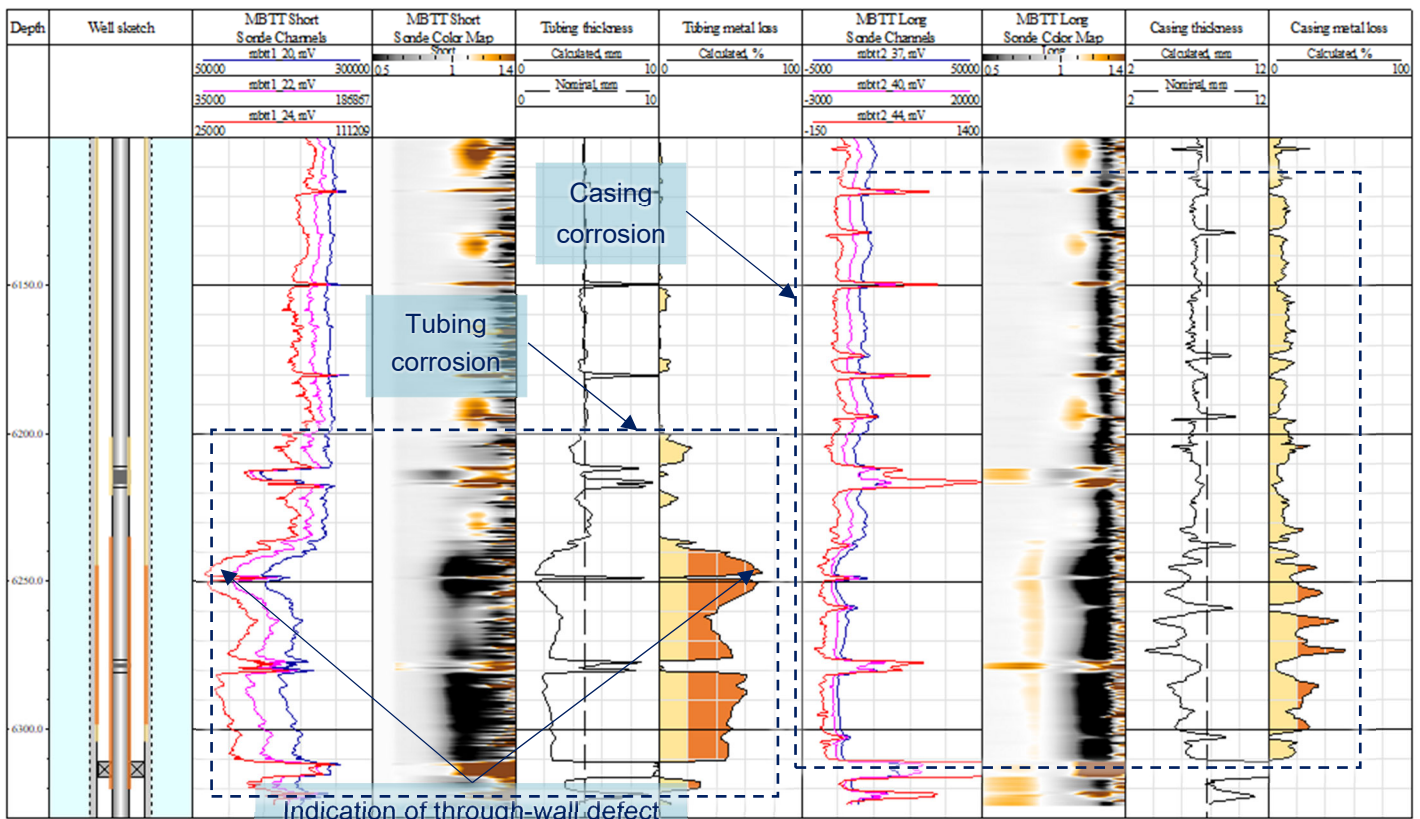
The corrosion logging results revealed severe tubing corrosion of up to 71% of average circumferential metal loss with a high possibility of through-wall defect across the bottom section above the tubing packer. In addition, the casing (2nd pipe) also appeared to be severely corroded across the same interval and above with a maximum circumferential metal loss of 48%.

Based on the log findings the tubing replacement was cancelled due to a high possibility of the tubing being parted during pulling operations.
