CASE STUDY

CORROSION LOGGING BY MBTT3 IN VERTICAL WATER INJECTOR UNDER THE HOIST. 24 HOURS OPERATION

Location: West Africa

Well type: vertical water injector

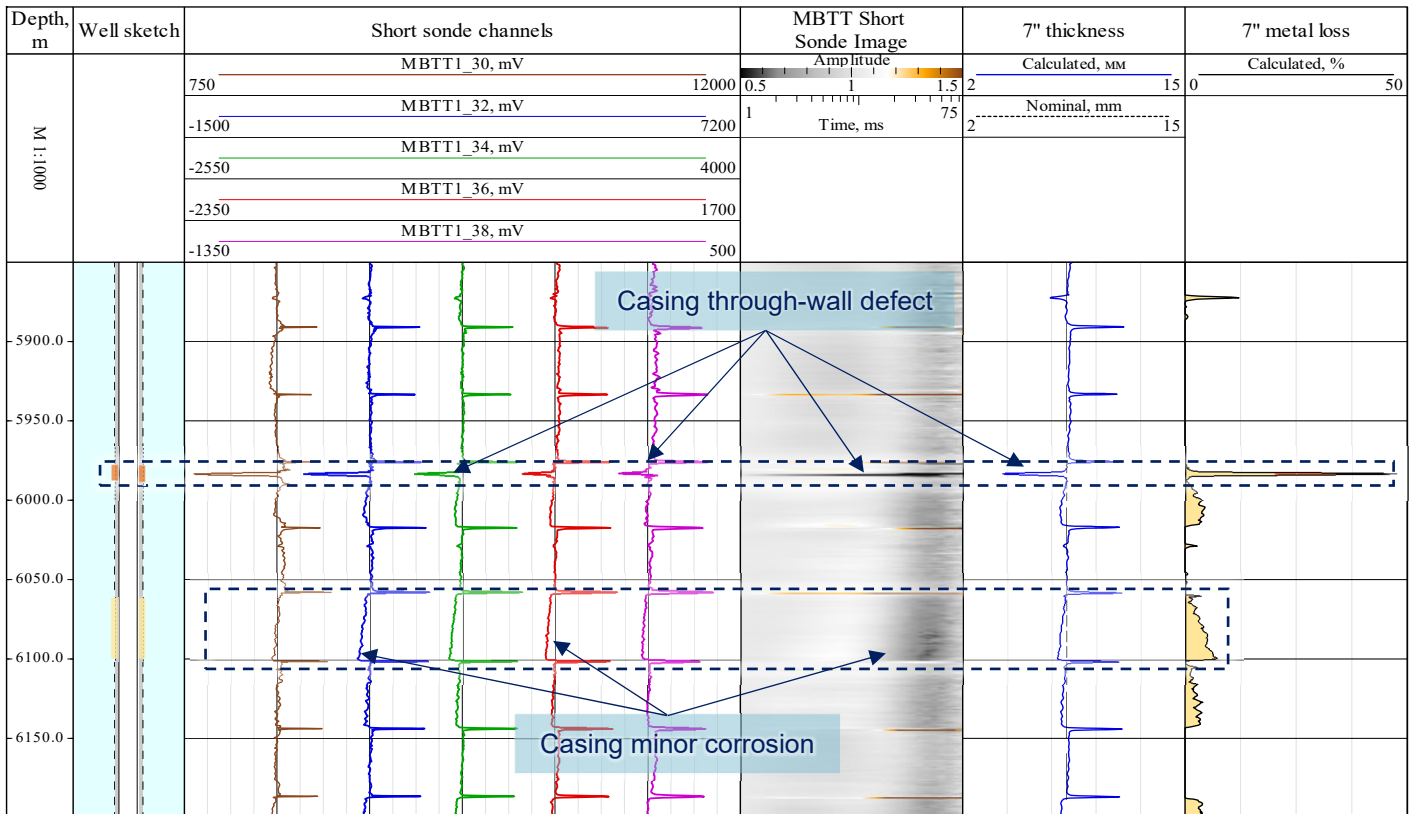
The corrosion logging results revealed severe casing corrosion of up to 47% of average circumferential metal loss with a typical indication of a through-wall defect.

In addition, multiple intervals of minor and moderate corrosion were also detected across the logged interval.

- Casing through-wall corrosion was detected
- The job was completed within 24 hours including SL logging and results delivery
- A successful patching job was conducted based on the logging results
