TUBING INTEGRITY EVALUATION BY STT IN A VERTICAL OIL PRODUCER WITH HIGH H₂S ENVIRONMENTS

Location: Middle East

Well type: vertical oil producer

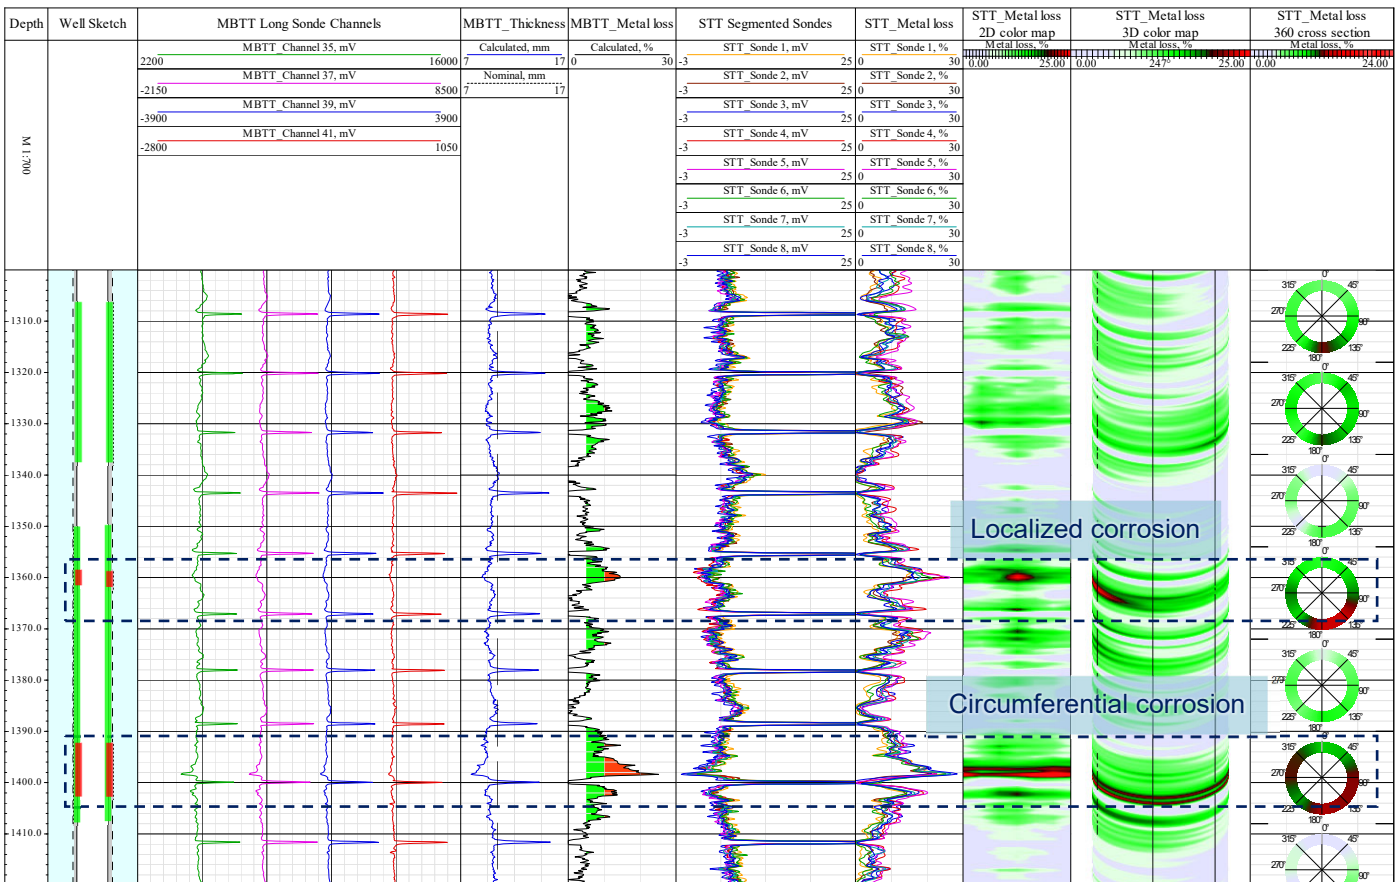
Based on MBTT data two major corroded areas were localized at 1358.0-1361.0 m and 1395.0-1399.0 m with 13% and 26% of an average circumferential metal loss respectively. The STT results confirmed the MBTT results, however, the area at 1358.0-1361.0 m was identified as a localized corrosion zone with a maximum metal loss level of 27%, while the area at 1395.0-1399.0 m showed a more uniform distribution of corrosion around the circumference with a slight increase of metal loss up to 29%.

- Localized zone of circumferential corrosion was discovered at 1395.0-1399.0 m
- This zone should be considered as a major weak point during the tubing retrieving operations
