## CASE STUDY

### THREE BARRIERS WELL INTEGRITY EVALUATION

#### MULTI BARRIER THICKNESS TOOL (MBTT)

**Location:** Middle East, Oman.

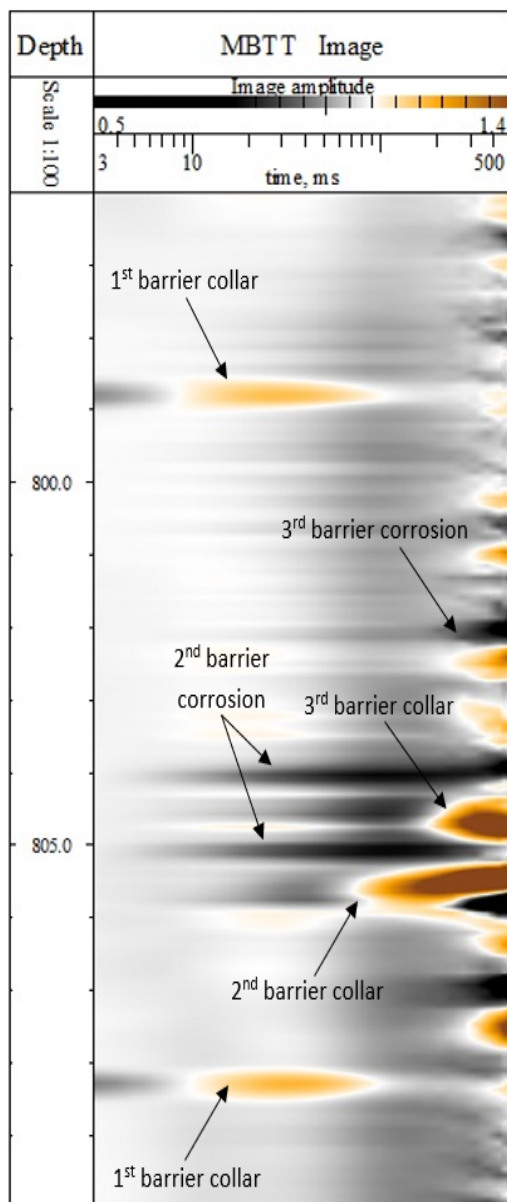
The header of the "MBTT Image" shows two scales. The upper one shows the color scale with the range of metal loss. The level of metal loss relates to changes of color palette from black color for metal loss to dark brown color for the metal increase. The header scale displays EMF decay values and allows the differentiation of time domains that correspond to a particular barrier (1<sup>st</sup>, 2<sup>nd</sup>, or 3<sup>rd</sup>).

The calculation of the metal loss percentage of each particular pipe is based on the behavior of the most relevant EMF decay curves in comparison with a baseline corresponding to a nominal pipe thickness. The North Side in-house software allows for determining the best match between the recorded data and the calibration database coming from the real field tests. The "MBTT Image" column is the easiest way to visualize the corrosion log data for the general corrosion overview and instant quality control.
